# UTMC Errata Sheet

## UT69151 S $\mu$ MMIT<sup>TM</sup> RTE Auto Initialization

UTMC has identified the following deviation from intended functional operation for prototype and reduced high reliability versions of the UT69151 S $\mu$ MMIT RTE (device code MM022A).

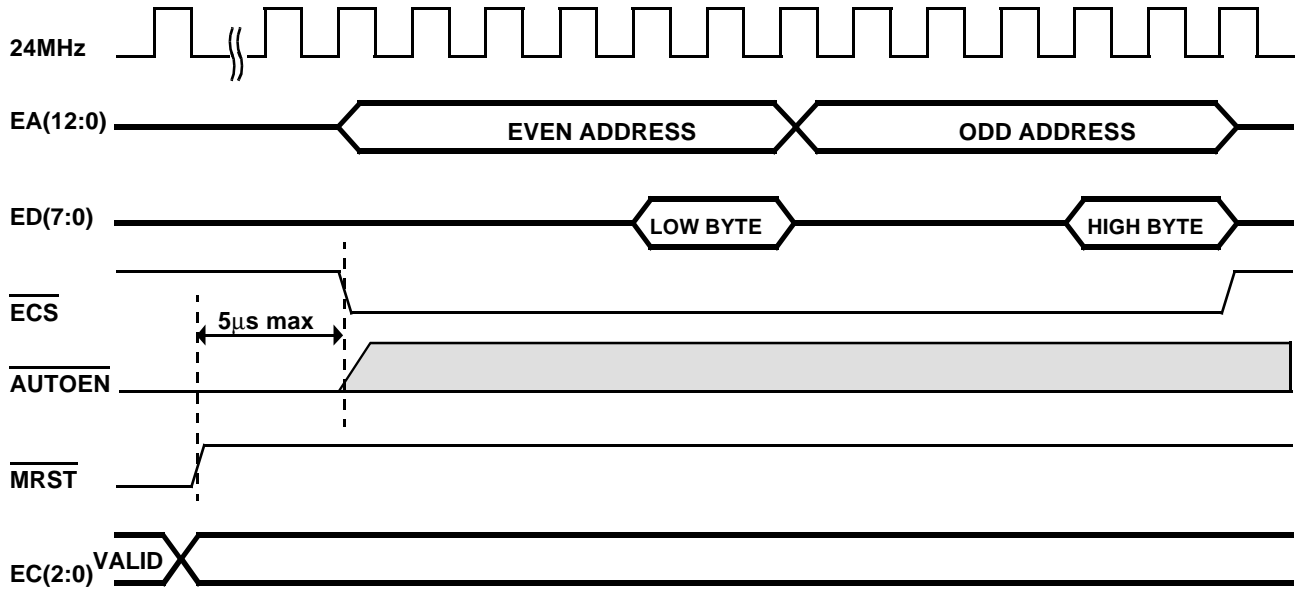
**Figure 2. Auto-Initialization Read Cycle (MM022A)**

Evaluation has determined that the UT69151 SμMMIT RTE (MM022A) reads the auto-initialization memory in a reverse (i.e., low byte followed by high byte).

The production revision of the UT69151 SμMMIT RTE (MM022B) will incorporate a circuit change to the address circuitry such that the high byte is read first (i.e., resides of even addresses) followed by the low byte (i.e., resides on odd addresses). Production versions of the UT69151 SμMMIT RTE, with the design fix, are scheduled for end 4Q98 deliveries. A system work-around is to change the auto-initialization memory such that high bytes reside on odd addresses and low bytes reside on even addresses.
