UTMC Errata Sheet

UT69151 SμMMIT RTE Register Compliance

UTMC has identified the following deviation from intended functional performance for prototype and reduced high reliability versions of the UT69151 SμMMIT RTE (device code MM022A).

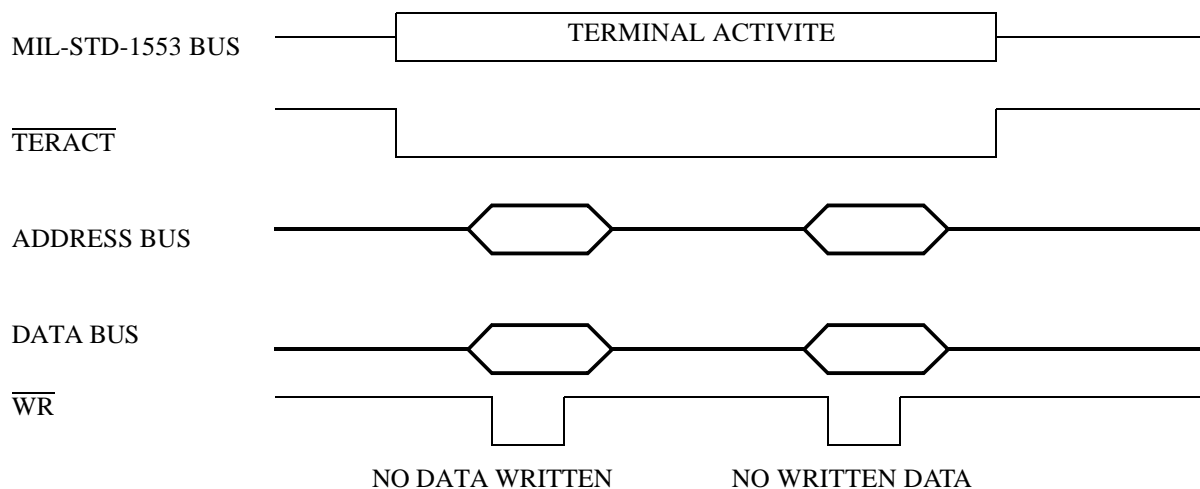
Figure 1. Corrupted Write Cycles

If the host processor attempts either a memory or registers cycle while $\overline{\text{TERACT}}$ is low, the host cycle is corrupted. The SμMMIT RTE indicates that MIL-STD-1553 message processing has started by asserting $\overline{\text{TERACT}}$ (i.e., active low). $\overline{\text{TERACT}}$ remains low until MIL-STD-1553 message processing completes. For write cycles, no data is written into either the protocol handlers register or into the cycle specific address location. For read cycles, invalid data is presented to the host on the SμMMIT RTE's external data bus. The anomaly occurs in all modes of operation bus controller, remote terminal and monitor. Additionally, the anomaly is independent of device is configuration, i.e., multiplexed, non-multiplexed, 8-bit mode, 16-bit mode.

The production revision of the UT69151 SμMMIT RTE (MM019B) will incorporate a circuit change to the MMU eliminating register and memory bus corruption during memory/register accesses occurring concurrently with MIL-STD-1553 message processing. Production versions of the UT69151 SμMMIT RTE, with the design fix, are scheduled for end 4Q98 deliveries. A system work-around is to eliminate memory or register accesses while the SμMMIT RTE is processing MIL-STD-1553 messages.
