UTMC Errata Sheet

UT69151 SμMMIT RTE Register Compliance

UTMC has identified the following deviation from intended functional performance for prototype and reduced high reliability versions of the UT69151 SμMMIT RTE (device code MM022A).

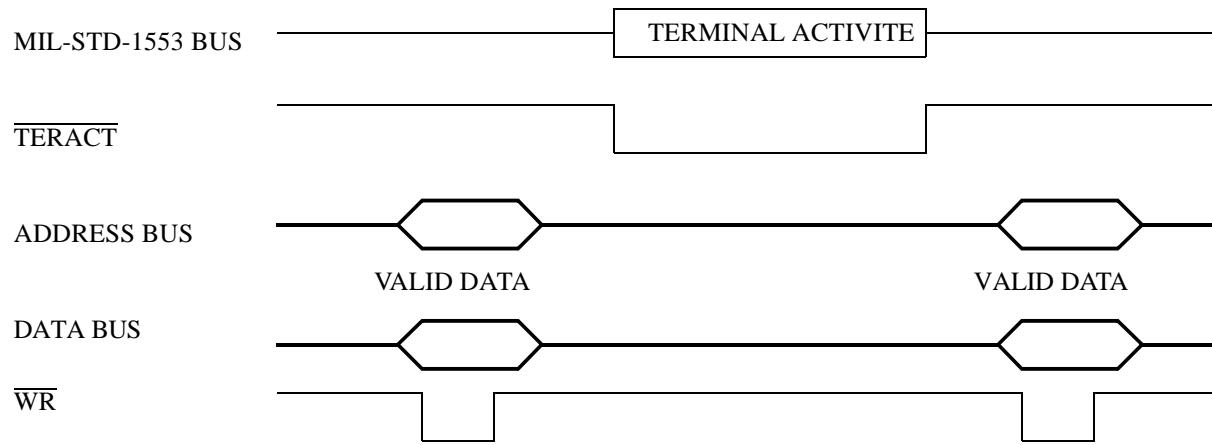
Figure 3. Valid Write Cycles

If the host processor attempts either a memory or registers cycle while $\overline{\text{TERACT}}$ is low, the host cycle is corrupted. The SμMMIT RTE indicates that MIL-STD-1553 message processing has started by asserting $\overline{\text{TERACT}}$ (i.e., active low). $\overline{\text{TERACT}}$ remains low until MIL-STD-1553 message processing completes. For write cycles, no data is written into either the protocol handlers register or into the cycle specific address location. For read cycles, invalid data is presented to the host on the SμMMIT RTE's external data bus. The anomaly occurs in all modes of operation bus controller, remote terminal and monitor. Additionally, the anomaly is independent of device is configuration, i.e., multiplexed, non-multiplexed, 8-bit mode, 16-bit mode.

The production revision of the UT69151 SμMMIT RTE (MM019B) will incorporate a circuit change to the MMU eliminating register and memory bus corruption during memory/register accesses occurring concurrently with MIL-STD-1553 message processing. Production versions of the UT69151 SμMMIT RTE, with the design fix, are scheduled for end 4Q98 deliveries. A system work-around is to eliminate memory or register accesses while the SμMMIT RTE is processing MIL-STD-1553 messages.
